NURU WOMEN GROUP

RAIN WATER HARVESTING SYSTEM AT MHERO PRIMARY SCHOOL PROJECT LUSHOTO TANGA TANZANIA

FINAL REPORT ON THE IMPLEMENTATION OF THE PROJECT

31stMarch 2011

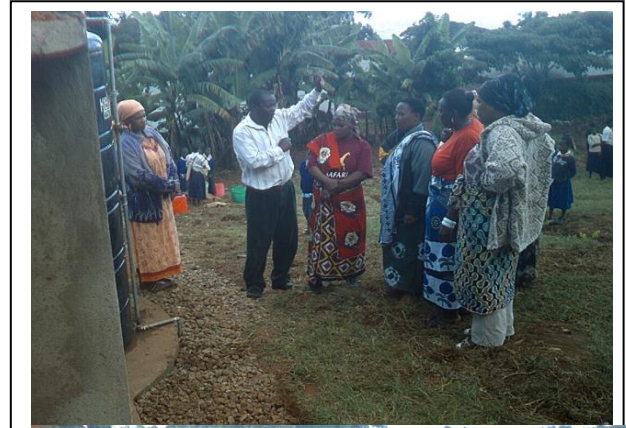
Picture2: Eng. Nshunju presenting technical issues of the system

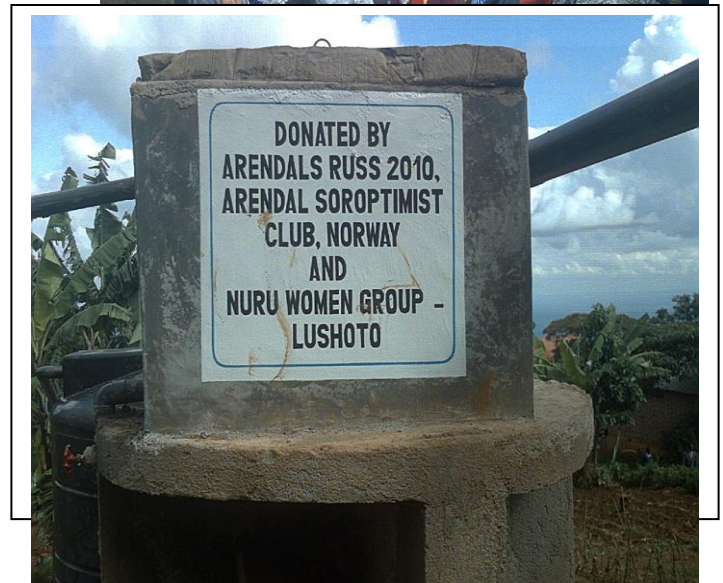
Picture 4: The signboard has been fixed to the first flush diversion unit.

- On start of downpour of rain the gate valves of the first flush diversion unit should be open to flush away foul water.
- On ensuring the clear flow, the gate valve on the downward pipe should be closed for clarified water to ascend to the gulley trap before entering into the tank.

- Regular cleaning of the foul flush diversion tank is recommended as well as gulley trap inside this unit.
- The foul flush has been diverted to the nearby bush by 11/2' PVC. The pipe end should be checked regularly to avoid blockage by debris and stones etc.
